712 West 12th Street Juneau, Alaska 99801

Suite 210 DOL Building Sampling, Remodel & Mold Abatement Summary

Suite 210 DOL Building Remodel & Mold Abatement

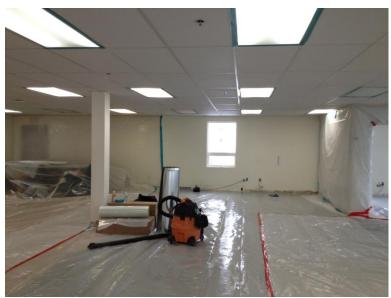
Photograph 1. Interior of containment in preparation for the remodel and abatement activities.

- 1) Site Preparation: Alborn Construction built containment around Suite 210 in preparation for the remodel and abatement activities. The enclosure was lined with two layers of 6-mil polyethylene sheeting and two negative-air machines with HEPA filtration were set up to create a negative pressure enclosure.

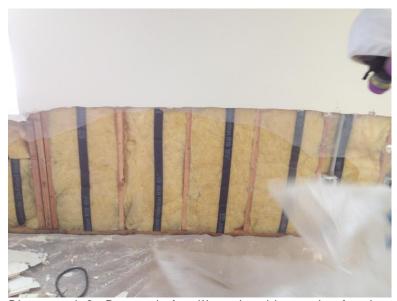
Photograph 2. Removal of wallboard and inspection for signs of mold growth.

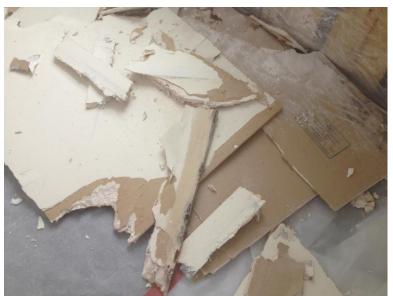
- In two areas on the east wall and three areas along the south wall, a patch of mold approximately 1 inch by 4 inches was noted on the back of the wall board along the bottom plate. All such areas were located under windows.

Photograph 3. Example patch of mold noted on the back of wall board along the bottom plate of south wall.

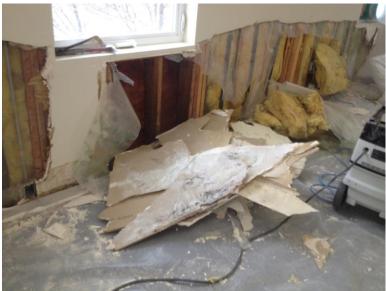
- In one area on the east wall and one area on the south wall, an area of light mold staining of approximately 1 square foot was identified.

Photograph 4. Area of mold approximately 1 square foot from south wall.

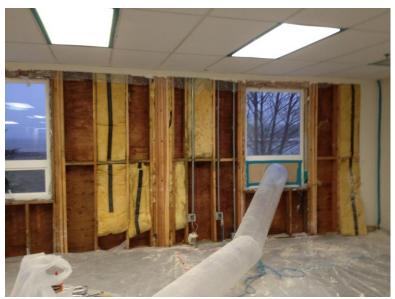
Material Removal – Insulation and Studs: Fiberglass insulation was intact, dry, and in good condition. Sheathing and wall framing (studs) were tested for moisture content and found to be dry. All areas measured less than 10% moisture, which is low, particularly in a damp climate like Southeast Alaska. Some areas showed staining from contact with sheathing that had likely experienced water damage before the siding replacement project in 2007. Insulation around windows and stained insulation was removed.

Photograph 5. Insulation around windows and stained insulation was removed.

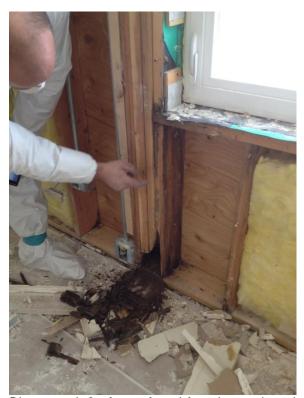
One area of framing under a window on the east side showed signs of past water damage that had affected the strength of the wood (this area was dry during the inspection). During the siding replacement project in 2007, additional studs had been added to take the load of the damaged stud. With the wall board removed, Alborn Construction took the opportunity to remove the damaged wood and replace it with new, clean wood.

Photograph 6. Area of stud framing under window on east side showed sign of past water damage that had affected the strength of wood.

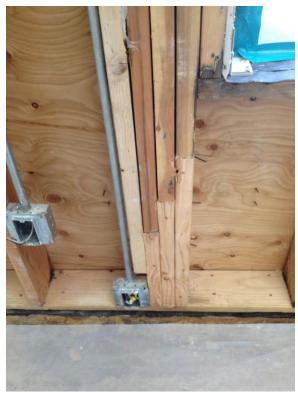
Photograph 7. Damaged stud section removed and replaced with new wood.

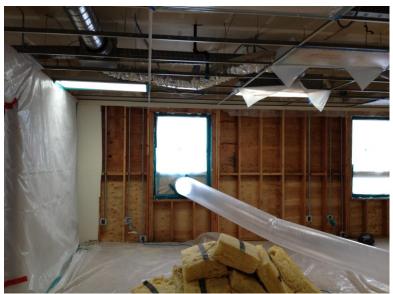
5) Material Removal – Ceiling Tiles: Ceiling tiles were removed and the above-ceiling space was inspected for any signs of water intrusion. It appears that in this area of the building, water intrusion had not occurred through the ceiling.

Photograph 8. Ceiling tiles removed and the above-ceiling space was inspected for water intrusion.

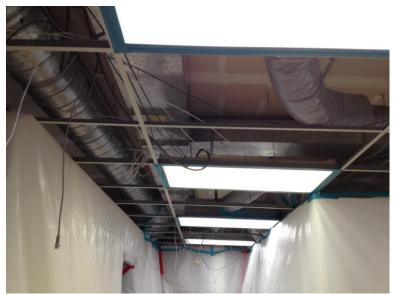
Flexible ducting serving supply air ducts was inspected at this time. Some of the flex ducting showed signs of wear so it was removed and replaced with new flex ducting. All louvers to supply ducts were opened to allow good air flow into Suite 210.

Metal ducting was inspected and was found to be clean and in good condition.

Photograph 9. Flexible ducting and metal ducting was inspected.
